# Manhole Inspection Summary

Manhole # S41G\_\_042MH

Insp Date: **5/19/08 11:42 AM**

**Location** Address: **1150 lombard st**

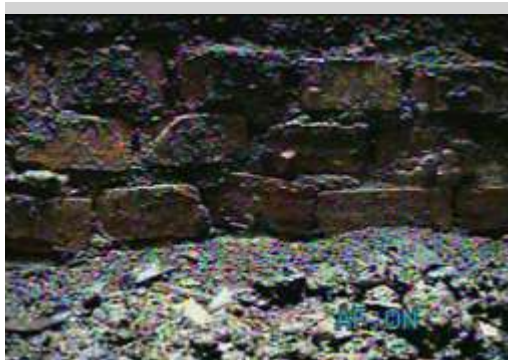
Defect 1

Condition: ☐ Sound ☐ Cracked ☐ Root Intrusion ☐ Deteriorated ☐ Leaks ☒ **Debris**

bench cond debris and bench debris

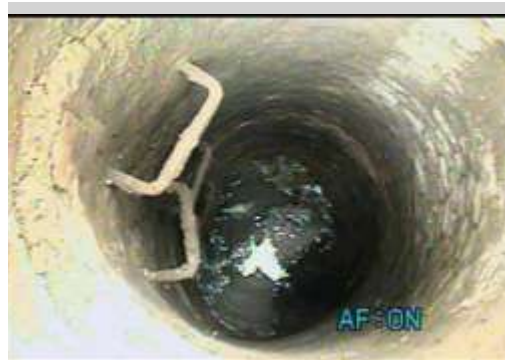
Defect 2

Infiltration: ☐ None ☒ **Joint** ☐ Cracks ☐ Mortar ☐ Roots ☐ Wall

**Steps** Count: **7** Missing: **0** ☒ **Corroded**

**Surcharge** ☒ **Evidence Of Surcharge** Depth: **6** (ft.) ☐ Active Surcharge Present

corroded steps, infiltration from corbel joint, surcharge evidence

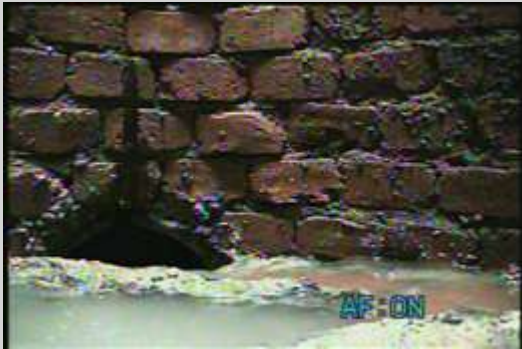
12 O'Clock Outflow

Deposits: ☐ None ☐ Mud ☐ Sludge ☒ **Debris** ☐ Grease

Silt Depth: 5 (in.) Deposits Extent: **Heavy**

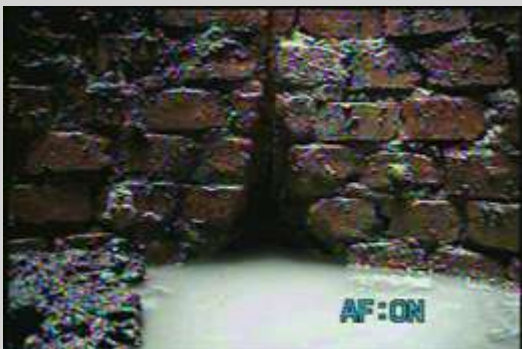
6 O'Clock Inflow

Deposits: ☐ None ☐ Mud ☐ Sludge ☒ **Debris** ☐ Grease

Silt Depth: 5 (in.) Deposits Extent: **Heavy**
